Hints & Kinks:  
Twenty Years of the

# California Historical Radio Society

For the Restoration and Preservation of Early Radio

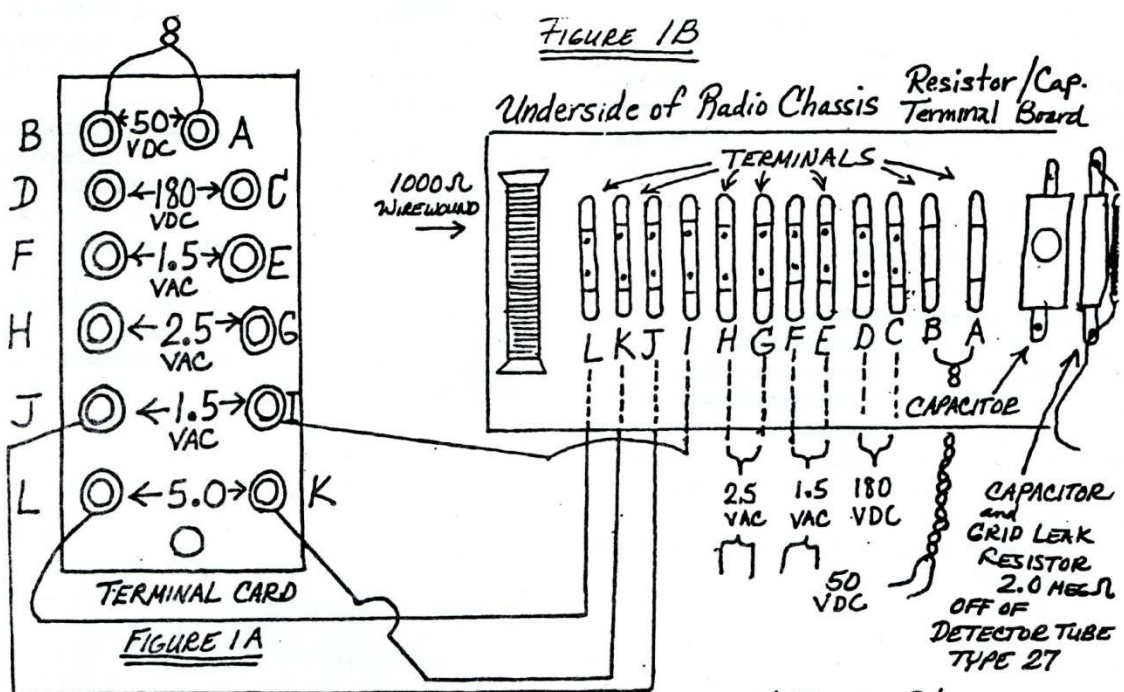
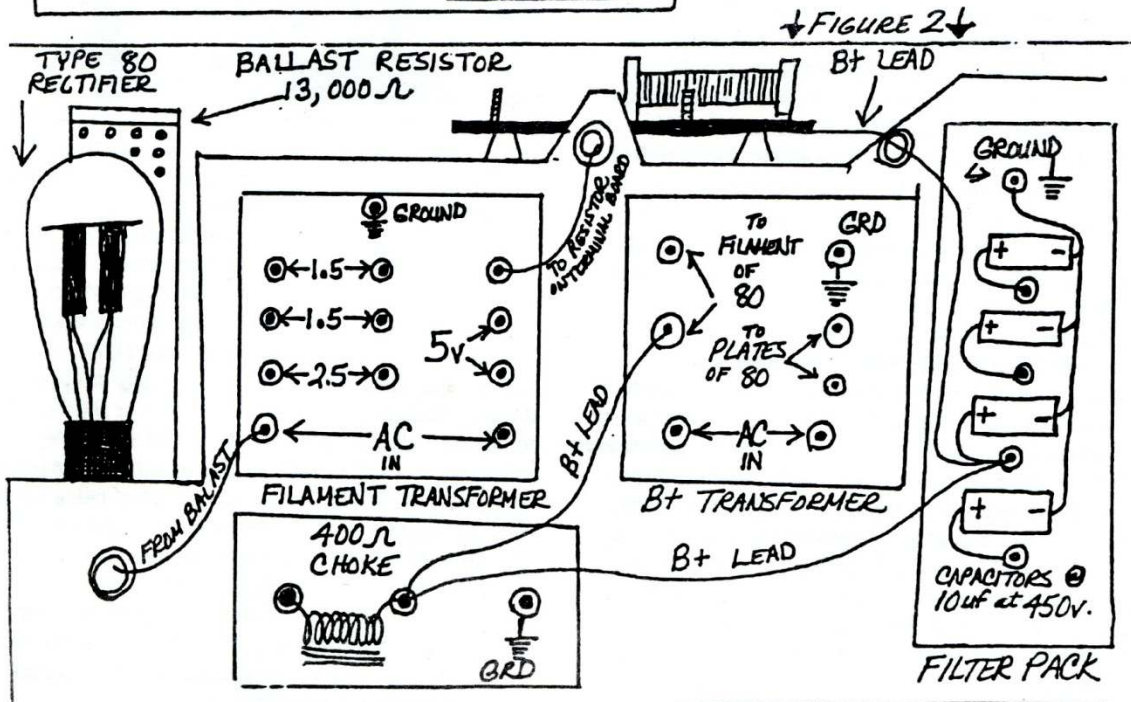
SIDE VIEW OF POWER SUPPLY (WITHOUT WIRING, EXCEPT B+ LEAD) FOR CHASSIS - 70 or 70B

transformer; the B+ transformer: the filter choke; and the filter capacitor pack. All units can be removed individually, if necessary. Replace each lead with a new wire, and remove them individually to avoid confusion with the wiring (see figure 2 for layout of the terminals on the power supply). It will be necessary to remove the terminal strip on the top of the power supply to remove have access to the wiring underneath.

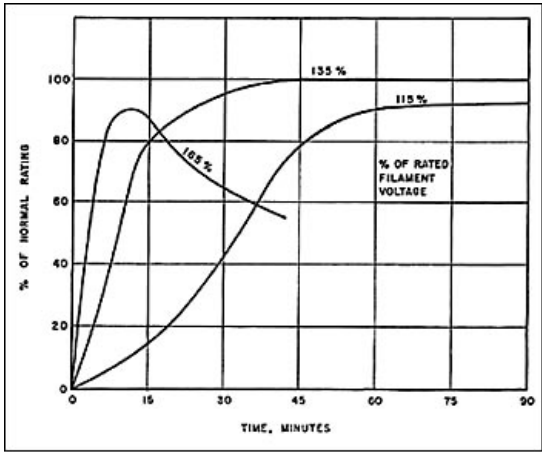
Summary of data accumulated by author on rejuvenation of thoriated tungsten filaments. Best results are obtained at 135% of rated filament voltage. At 115%, rejuvenation time is very significantly increased; at 105%, the tube is quickly destroyed.

The thoriated tungsten filament is probably the one most dealt with by the collector. This filament is a composition of tungsten and thorium with the tungsten acting as the heat source while the thorium is the emitting source. This filament was used in tubes such as the UX200A, UX201A, UV99, UX99, UX120, UX210, and in many of the later and present day transmitting tubes. Two methods are used for rejuvenation of these filaments. If a tube is only weak or gives erratic readings, the first procedure should be tried. If a tube is completely dead but the filament lights up, then the second procedure should be used. 1) operate the filament at 135% of the rated voltage for 30 minutes. Test the tube. If the tube has improved but is still not to rating, continue for another hour. If, at the end of this time, the tube is still not up to specification, use the next procedure. 2) In this procedure the filament is run white hot to strip the emitting surface completely clean, then the surface is restored using the above procedure. Operate the filament for 15 to 20 seconds at 350% of rated voltage with no other voltages applied. Then operate the tube under the conditions given in the first procedure. Test the tube every 30 minutes and if the tube is not up to rating after two hours, it has reached the end of its useful life. Note: Do not attempt to test the tubes at the end of the first step as there will be no emission.

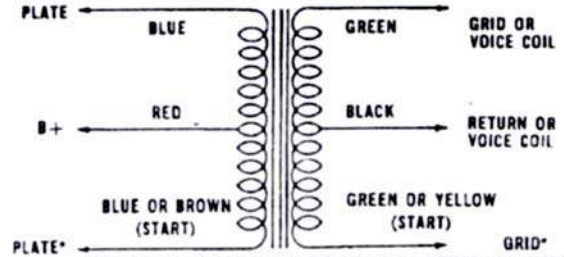
## AUDIO & OUTPUT TRANSFORMERS

\*FOUND ONLY ON PUSH-PULL PRIMARY OR SECONDARY WINDINGS

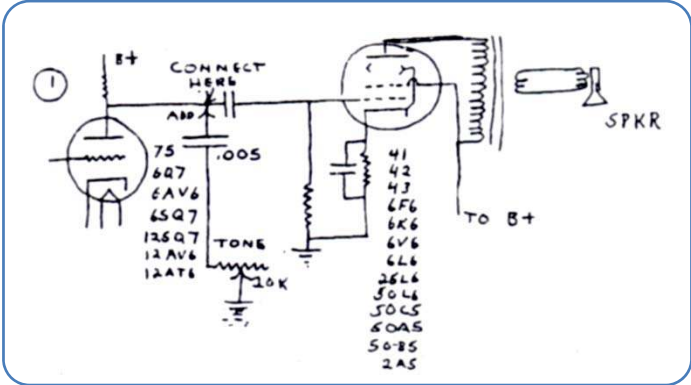
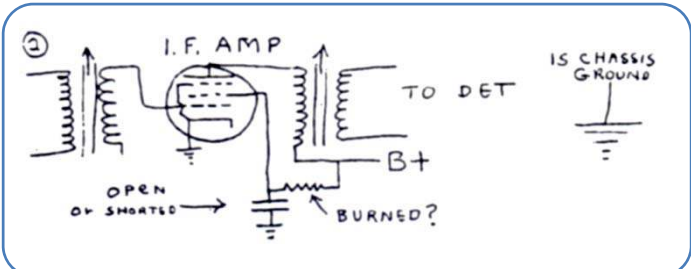
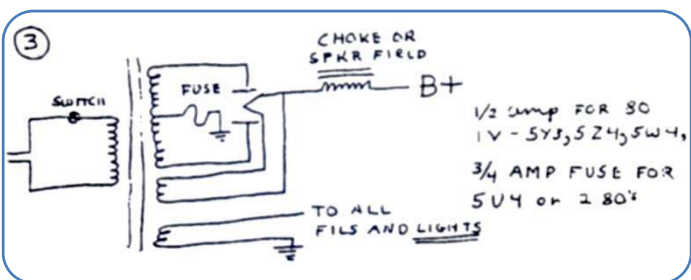
- 4. To protect a power transformer in a set, install a 1/2 amp fuse between the high voltage secondary center tap and ground. In some sets the secondary does not go straight to ground. In this case, place the fuse between the secondary center tap and the rest of the circuit. It is also a good idea to check all dial light wires. (See diag. 3).

- 6. Tone controls may be added to any radio! To do so add a 0.005 mfd. @ 600 volt capacitor from the plate of the first audio amplifier through a 20K pot to ground (See diag. 1).

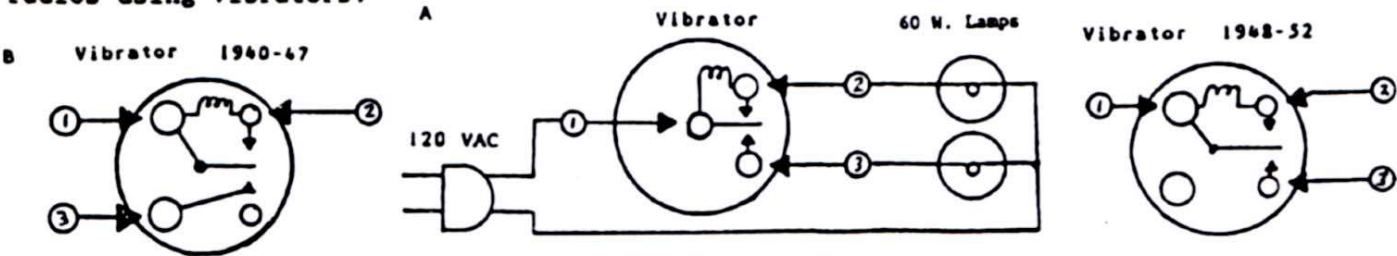
**Diagram B applies to 6 V. 4 pin vibrators used from 1940 thru 1952. Note the two different internal connections and two different pin diameters.**

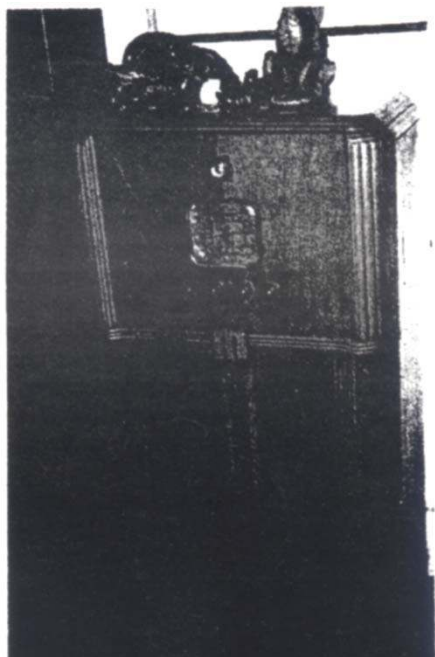
Refinished Delco

Although polyurethane is generally a bad choice for restoration, it does have its uses. In the console pictured here, a Delco from 1937-38, the top was warped, cigarette-burned, tinged and desiccated. I took it down to bare wood, filled it, stained it, and then coated it with tinted polyurethane. This created a thick protective surface on the top of the console. Polyurethane can also be used underneath to counter-warp a bent wood piece. If I'd had a piece of beveled glass to tit the top, I might not have been tempted to use the polyurethane. The technique did work, however, and the top is nearly indestructible, and it looks good, too.

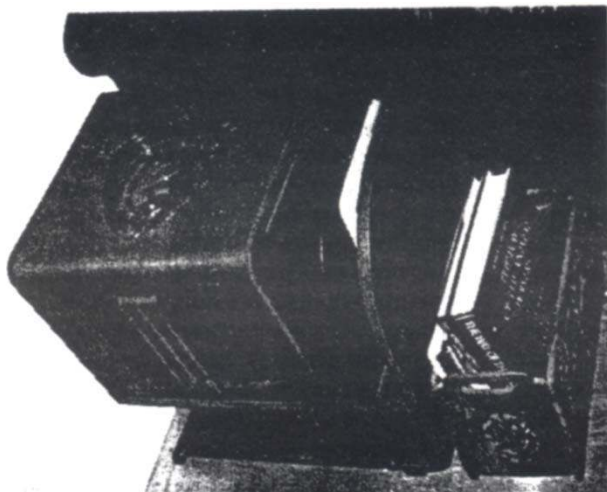
Refinished Zenith chairside

The two radios appearing nearby have had the benefit of this treatment. The Zenith chair-side was deeply ringed from what I hope was many a happy highball imbibed while listening to the BBC. The console was the worst radio I've ever seen at a swap meet; peeling veneer, water stained, sunburned, warping and cracking. After sanding and steel-wooling to bare wood all around, I followed the E-Z stain with red-oil furniture polish. When the wood is old and dry, this does not leave an oil residue after serious soft, dry cloth buffing. Elbow grease will prevent a greasy-appearing surface. The result is the stain's glow sustained by the polish. Try it first on an old radio with nothing left to lose. You will be pleased.

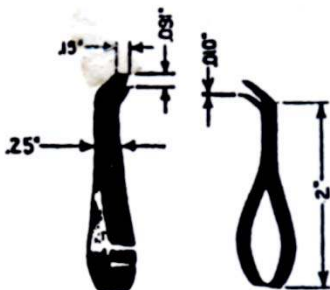
Fig. 3

Shim tools for adjusting speaker armature

Two of these tools are necessary when adjusting the armature. Place one tool in the space between the armature and pole piece of the motor mechanism at the end next to the filter unit (Fig 2).

The other tool is placed at the other end of the armature a little to one side in order to clear the drive pin located at this end of the armature. By loosening screw A and B (Fig. 2) any tension in either direction which may have been on the armature is released and the spacer tools will provide the correct clearance or spacing. While the spacer tools are in place a hot soldering iron is applied to the drive pin thrust lever, connection point C (Fig. 1), and the solder heated sufficiently to allow the drive pin to find its normal position with regard to the thrust lever. The iron is now removed. Screws A and B (Fig. 2) are tightened and the spacer tools removed. The armature is now correctly aligned and balanced so that no abnormal strain is being imposed upon it in any direction.

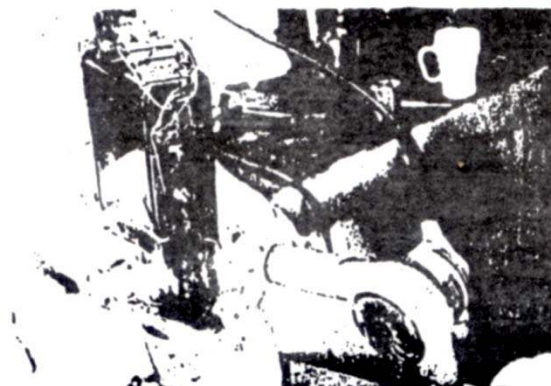
Melting out the tar with a heat gun

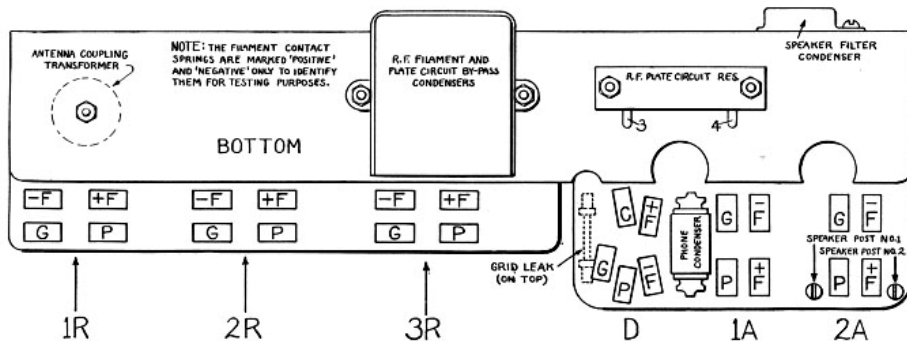
FIG. 90. CHART FOR MODEL 40, 40-F, 42, 42-F, 52, 56 AND 57.

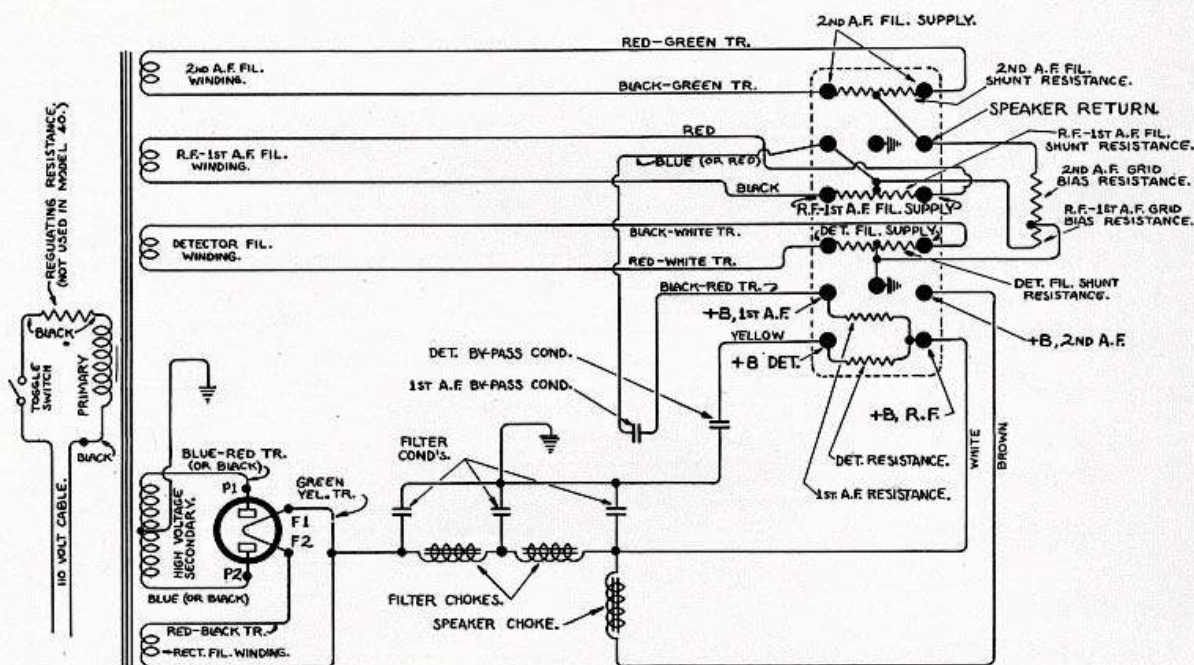
FIG. 63-A. SCHEMATIC DIAGRAM OF POWER UNIT IN MODELS 40, 42, 44, AND 52. SEE PAGE 69 FOR DESCRIPTION OF THIS UNIT. SOME EARLY UNITS OF THIS TYPE HAVE COLOR SCHEME SIMILAR TO UNIT IN MODEL 38 SET. NOTE THAT COLORS AS NOW STANDARDIZED CORRESPOND WITH THE COLORS OF SET-CABLE LEADS.

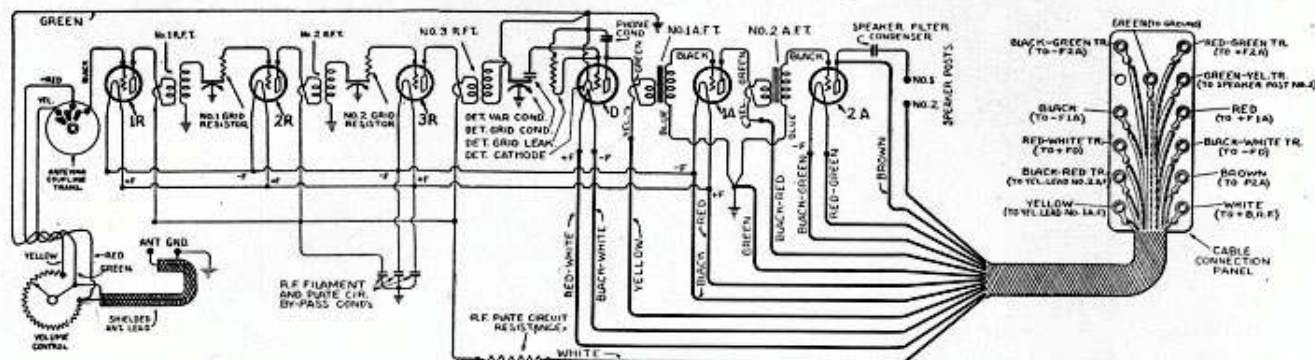
FIG. 87. WIRING DIAGRAM OF MODEL 40, 40-F, 42, 42-F, 52, 56 AND 57.

Model 52 does not have the shielded antenna lead, but is provided with two twenty-foot leads which are connected to the volume control, black for antenna and black-green for ground. Model 56 and 57 have antenna and ground posts at the bottom of the cabinet.
